A PHOTOGRAPHIC SURVEY OF THE
WILMINGTON & WELDON RAILROAD CORRIDOR

VOLUME I

(Ruins at Wilmington, NC, 2000-2001)

James C. Burke

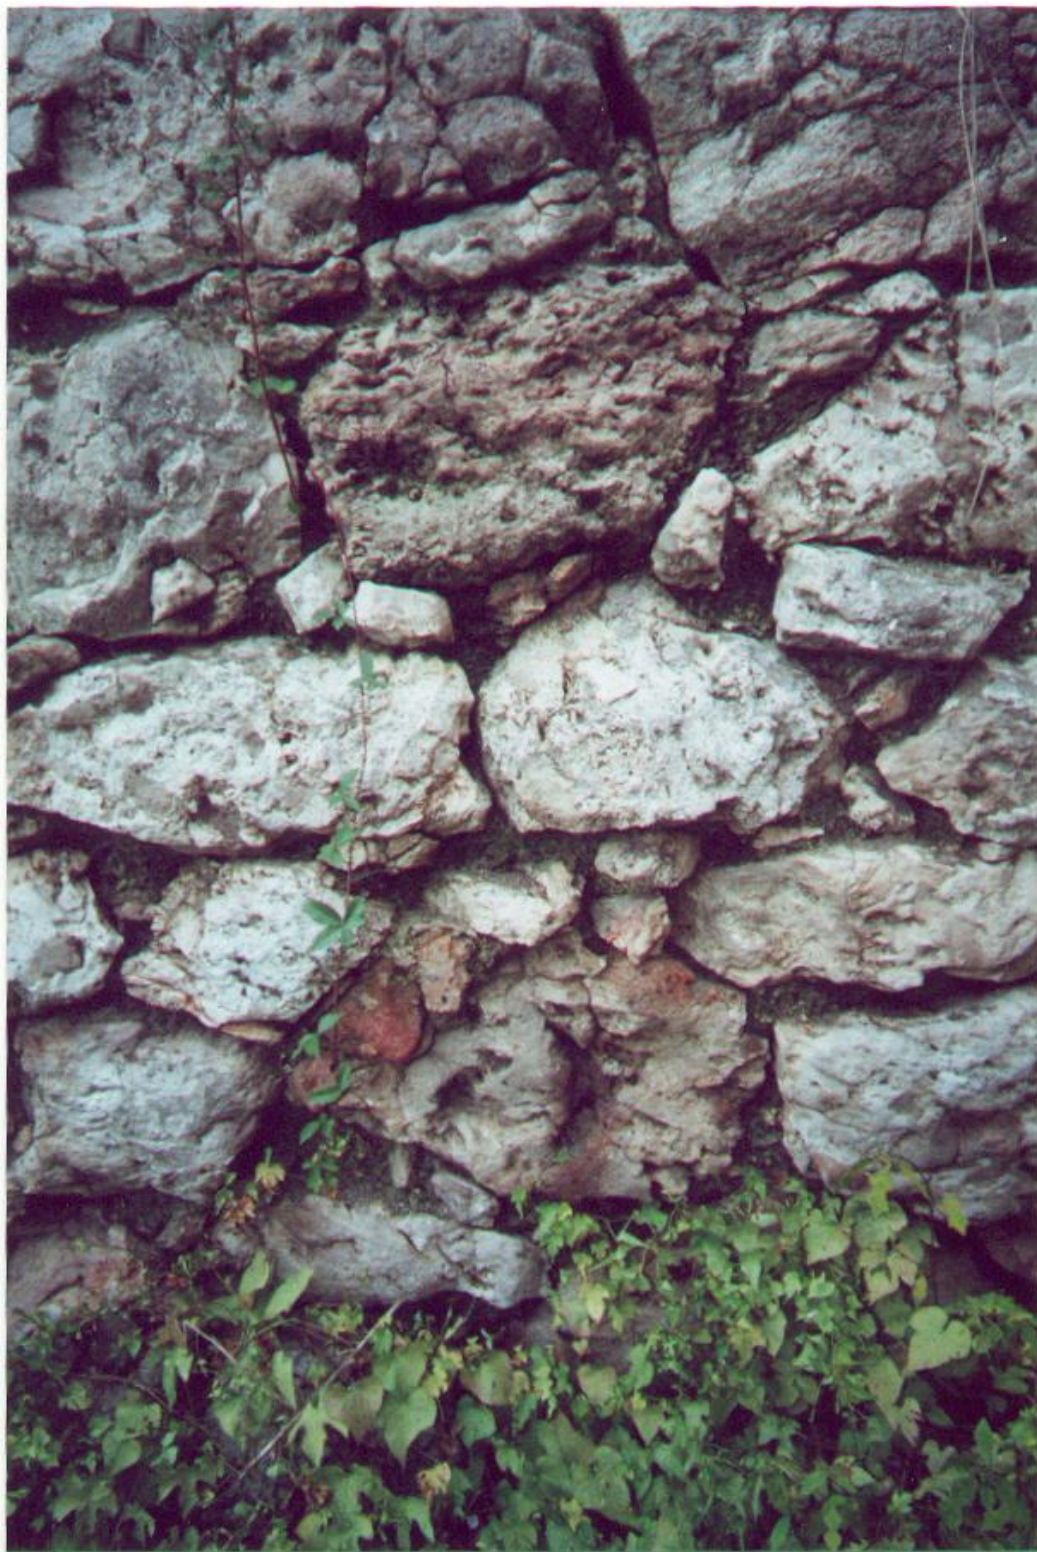
Figure 35

This is another view of conglomerate material in same wall.

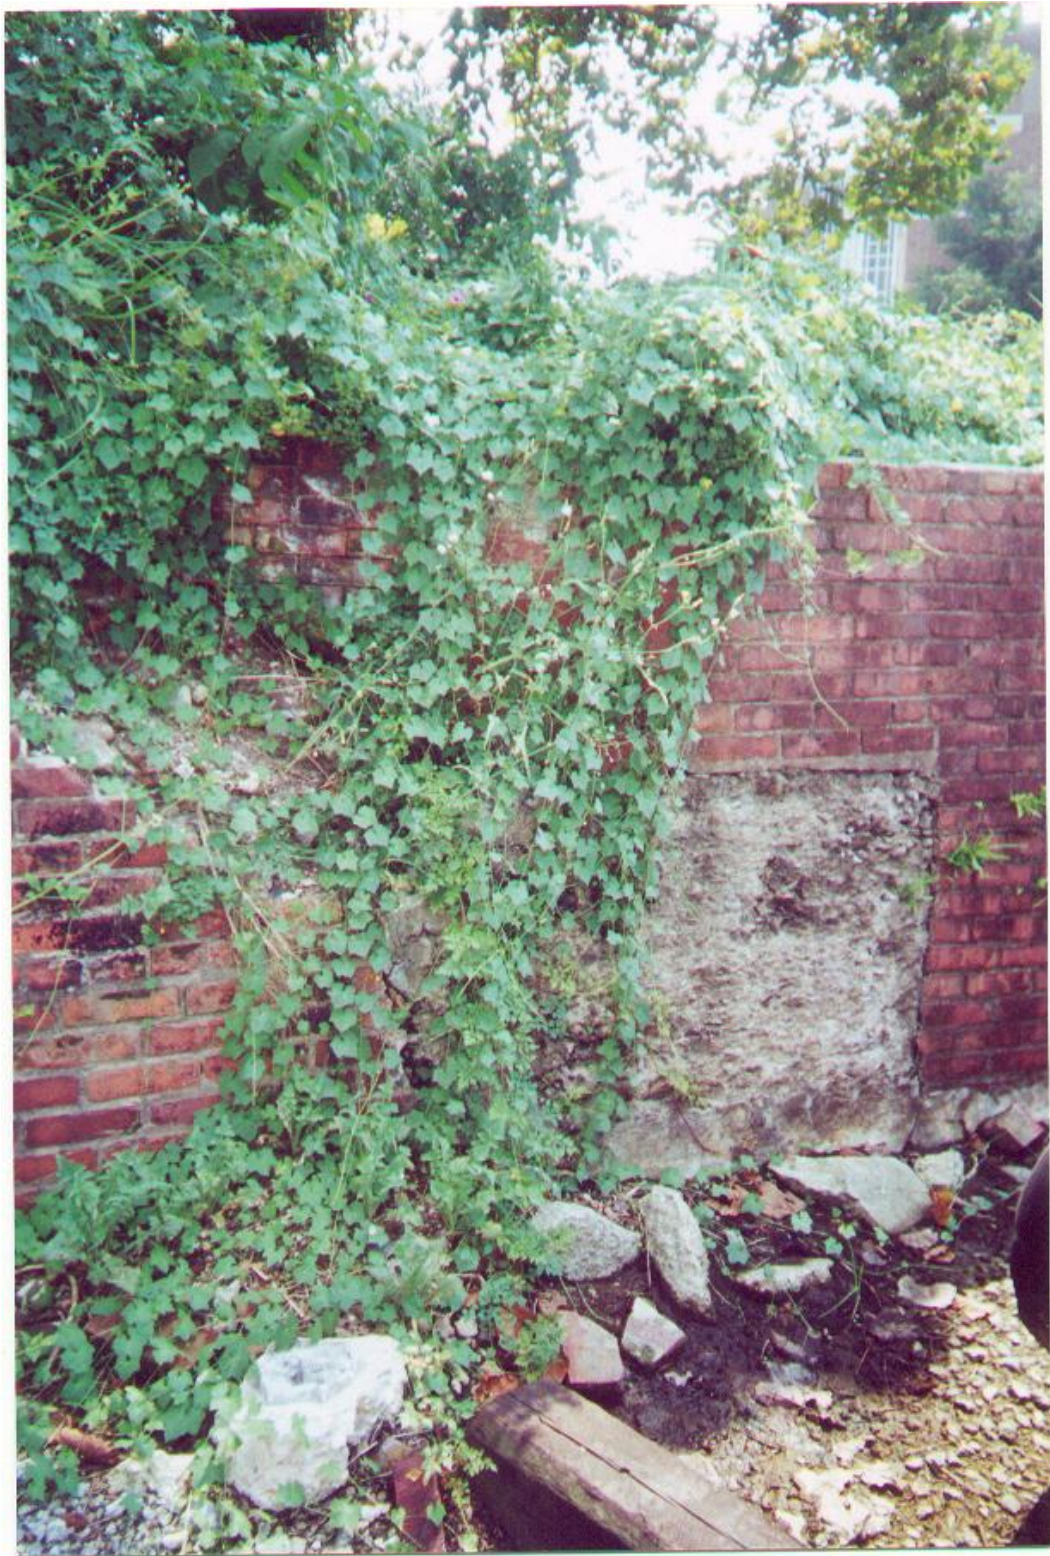
Figure 40

Concrete structure inset on wall in parking lot.

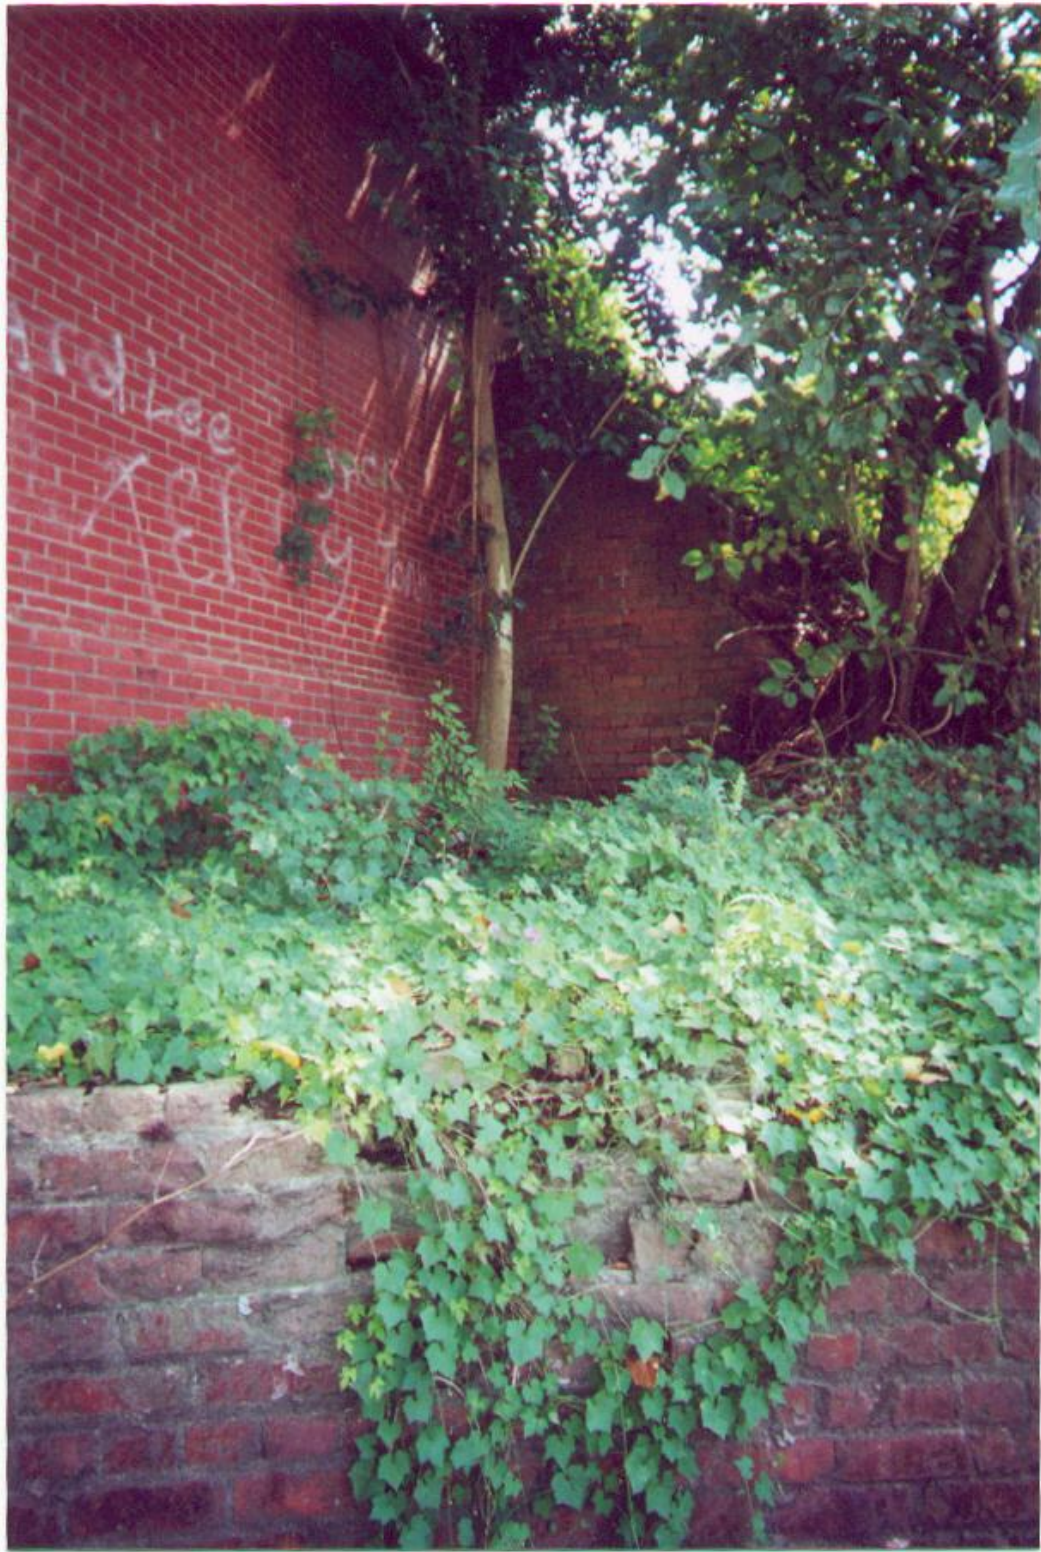
Figure 41

Old brick wall on the southeast side of the embankment of the Front Street Bridge.

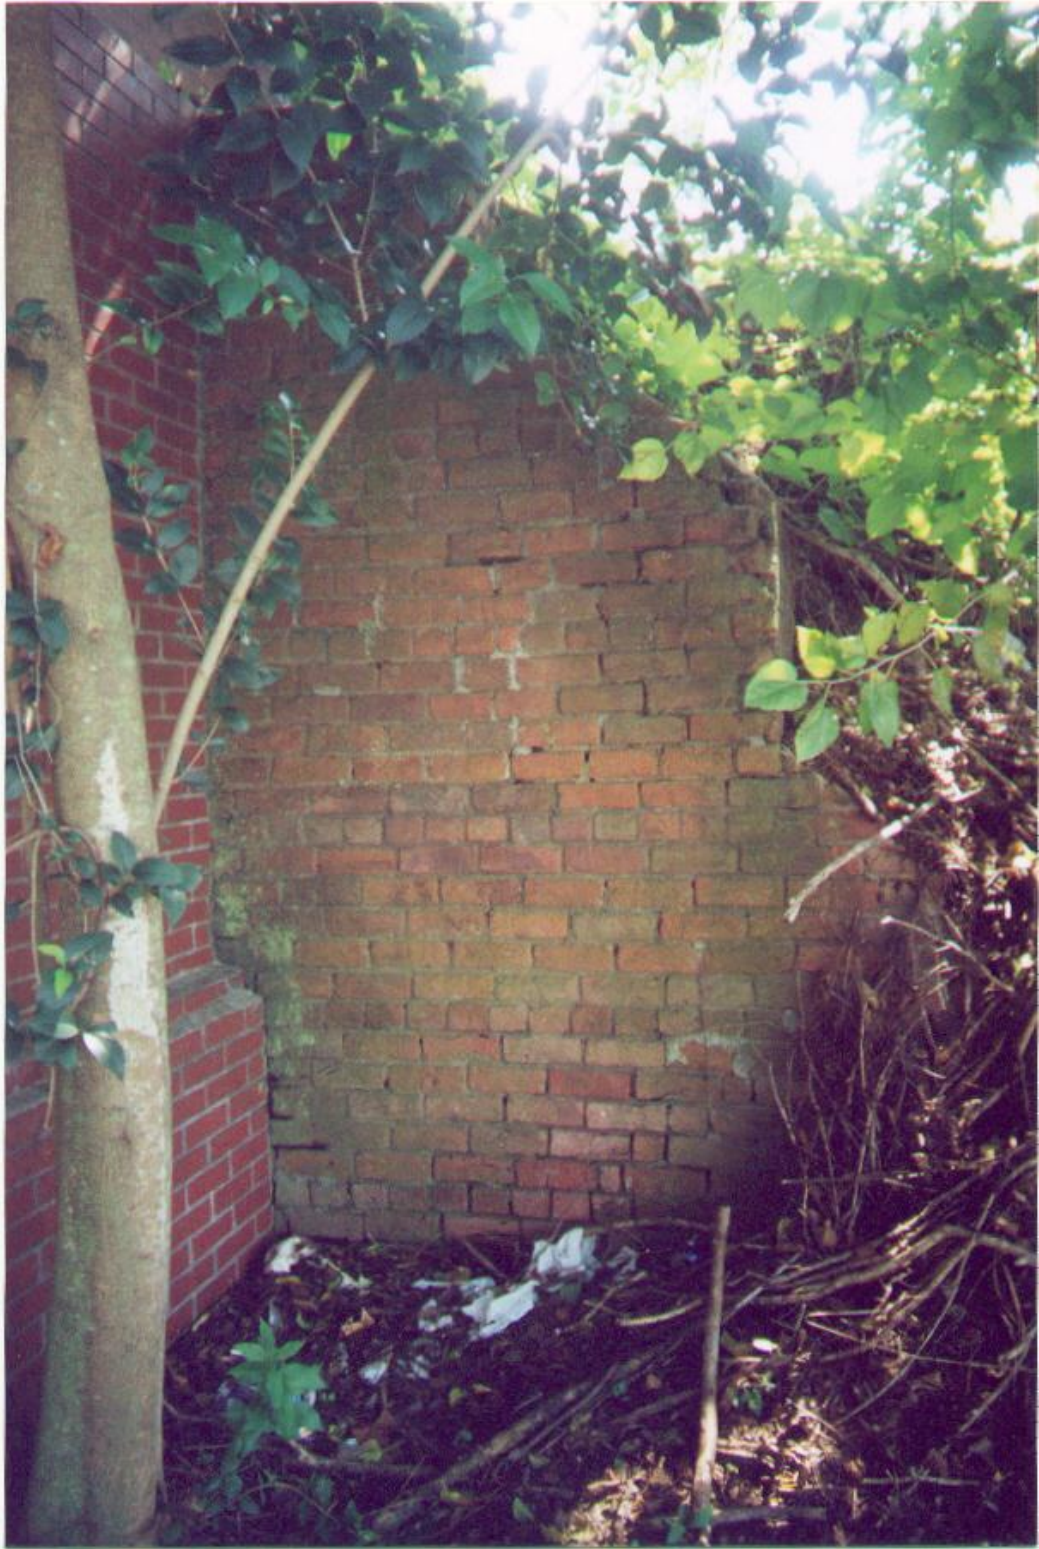
Figure 42

Detail of old brickwork on the same wall as Figure 41.

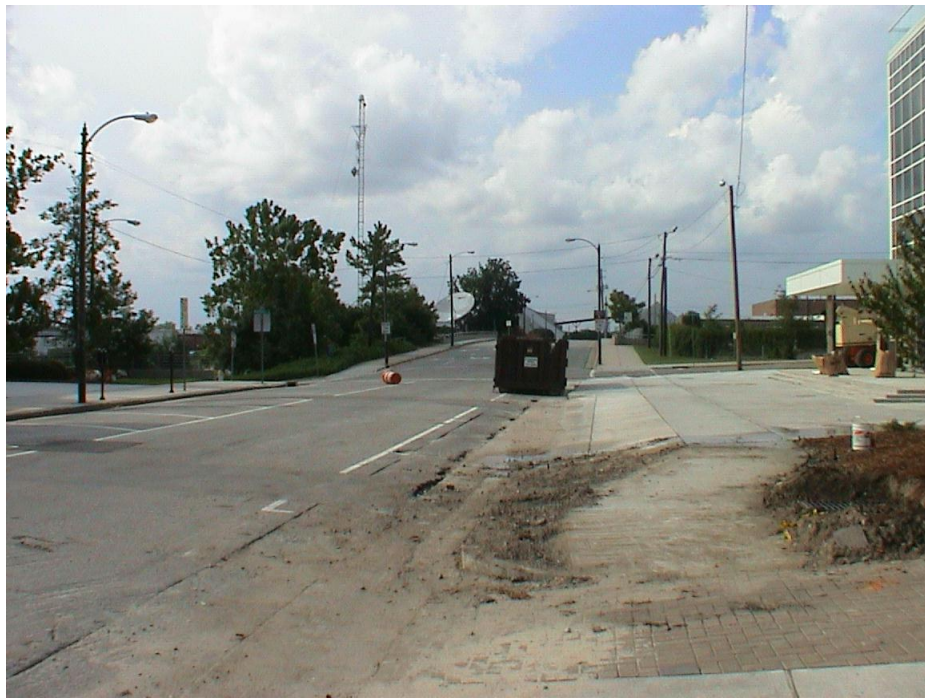
Figure 48

South side of Front Street facing Front Street Bridge.

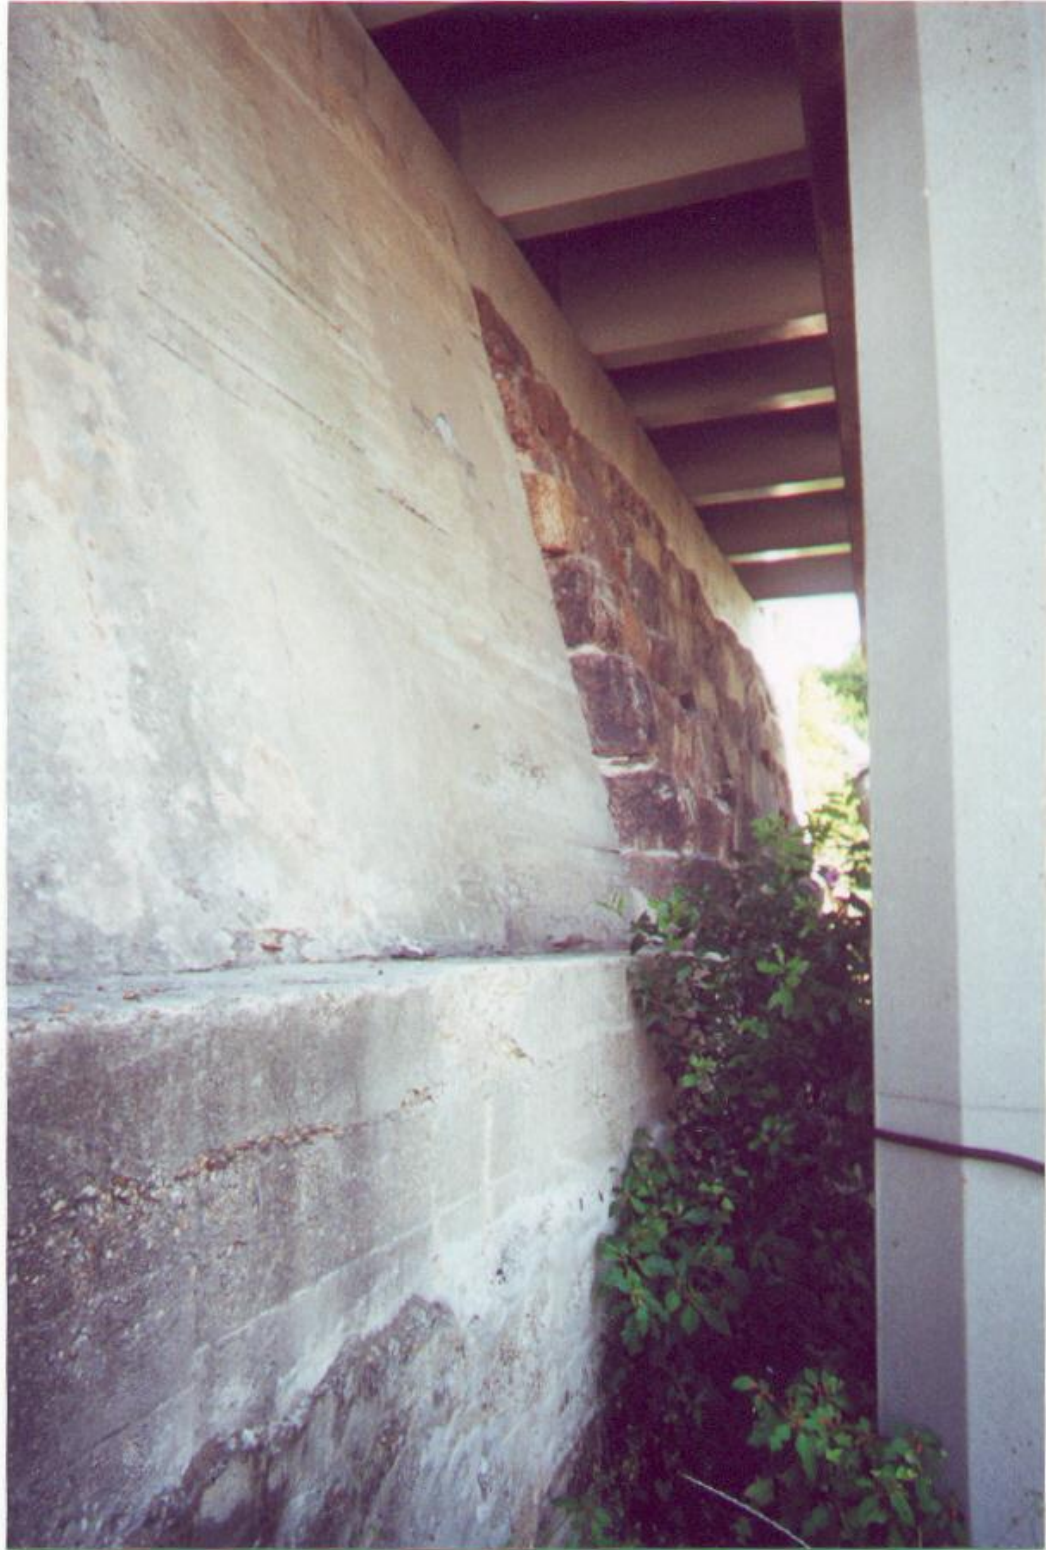
Figure 49

Old buttress of stone retaining wall with more recent concrete structures at the north side of the Front Street Bridge.

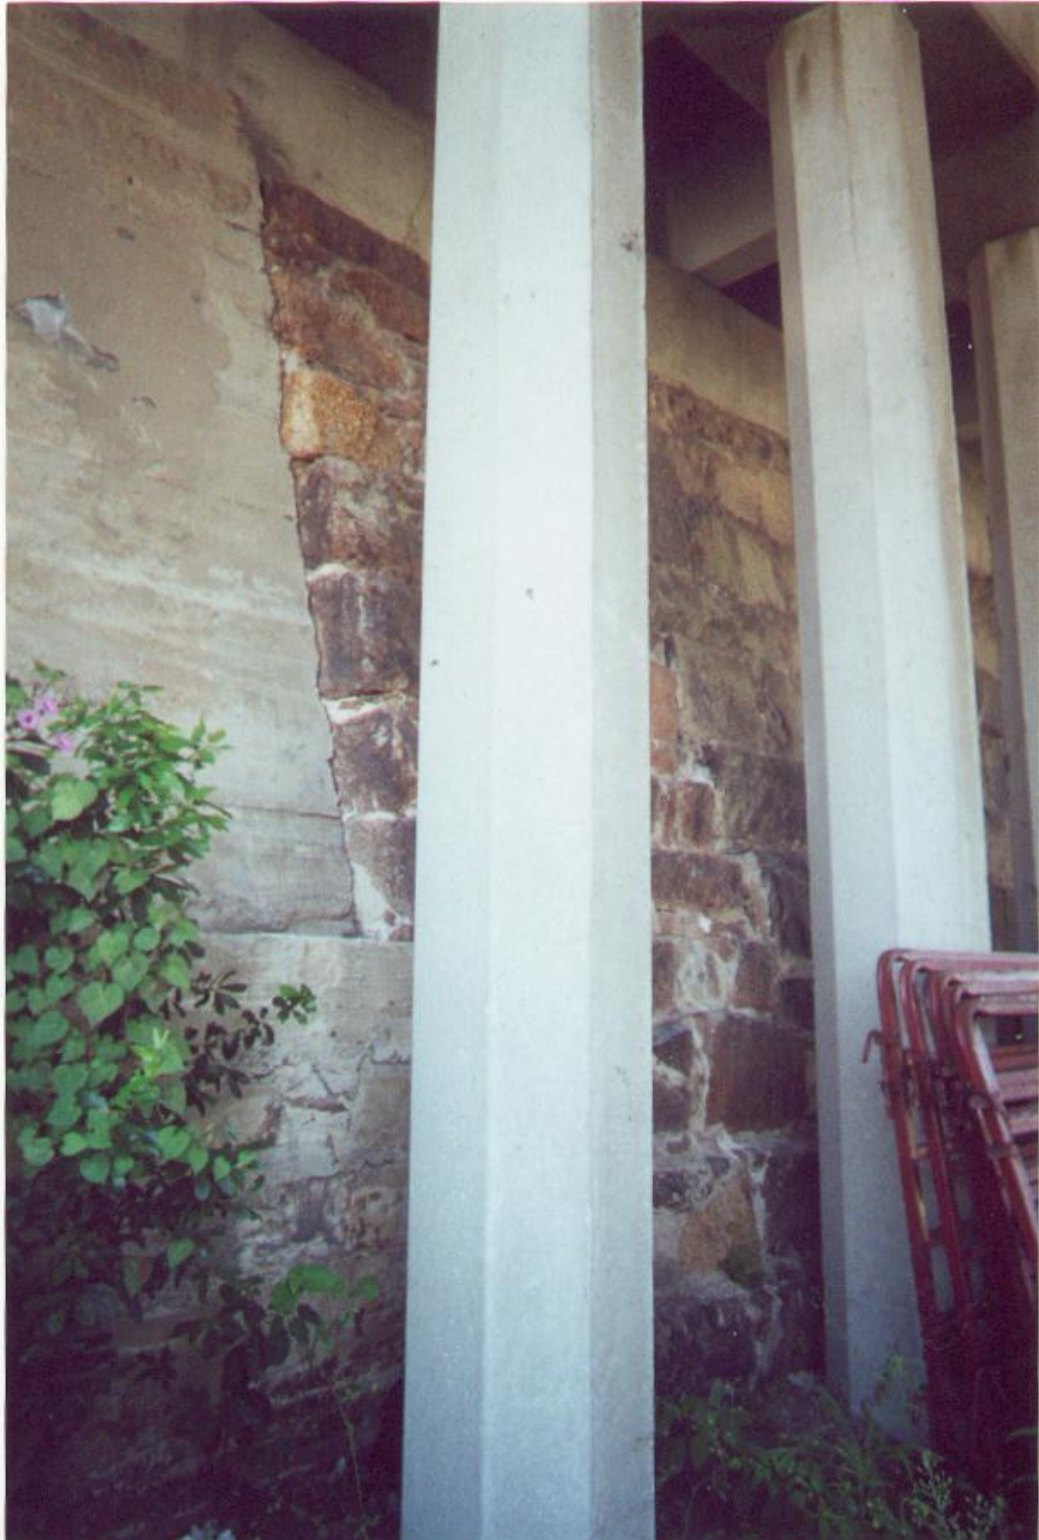
Figure 50

A different view of the same wall as shown in Figure 49.

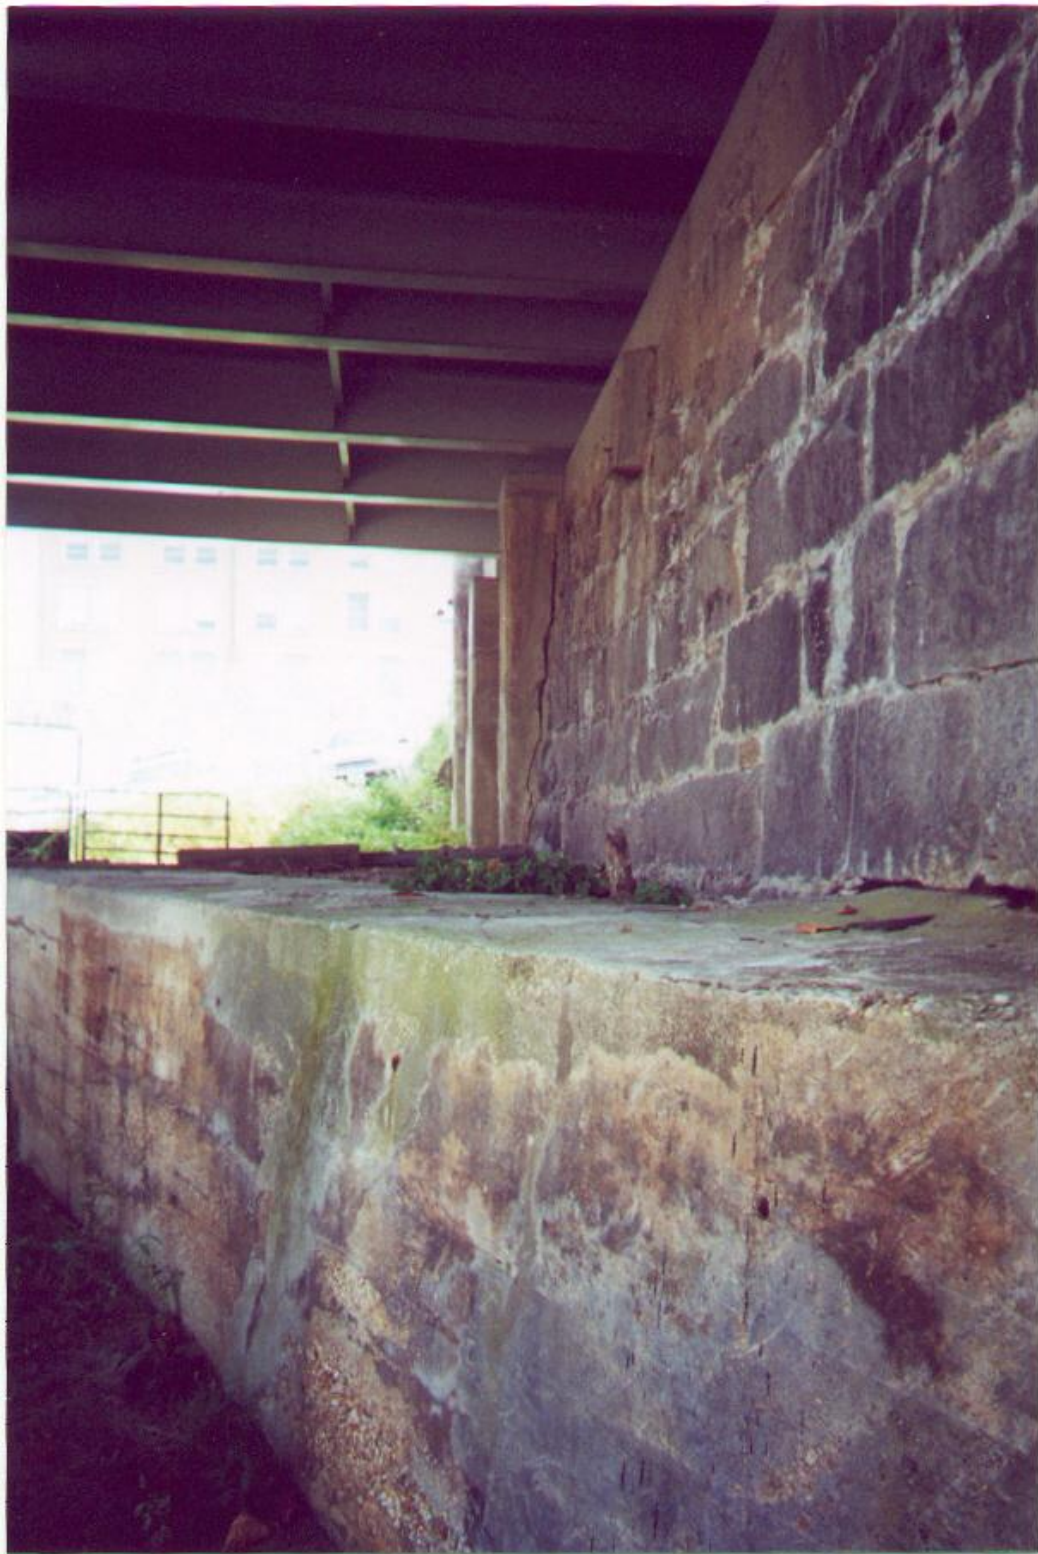
Figure 51

Stone and concrete structures under the south side of the Front Street Bridge.

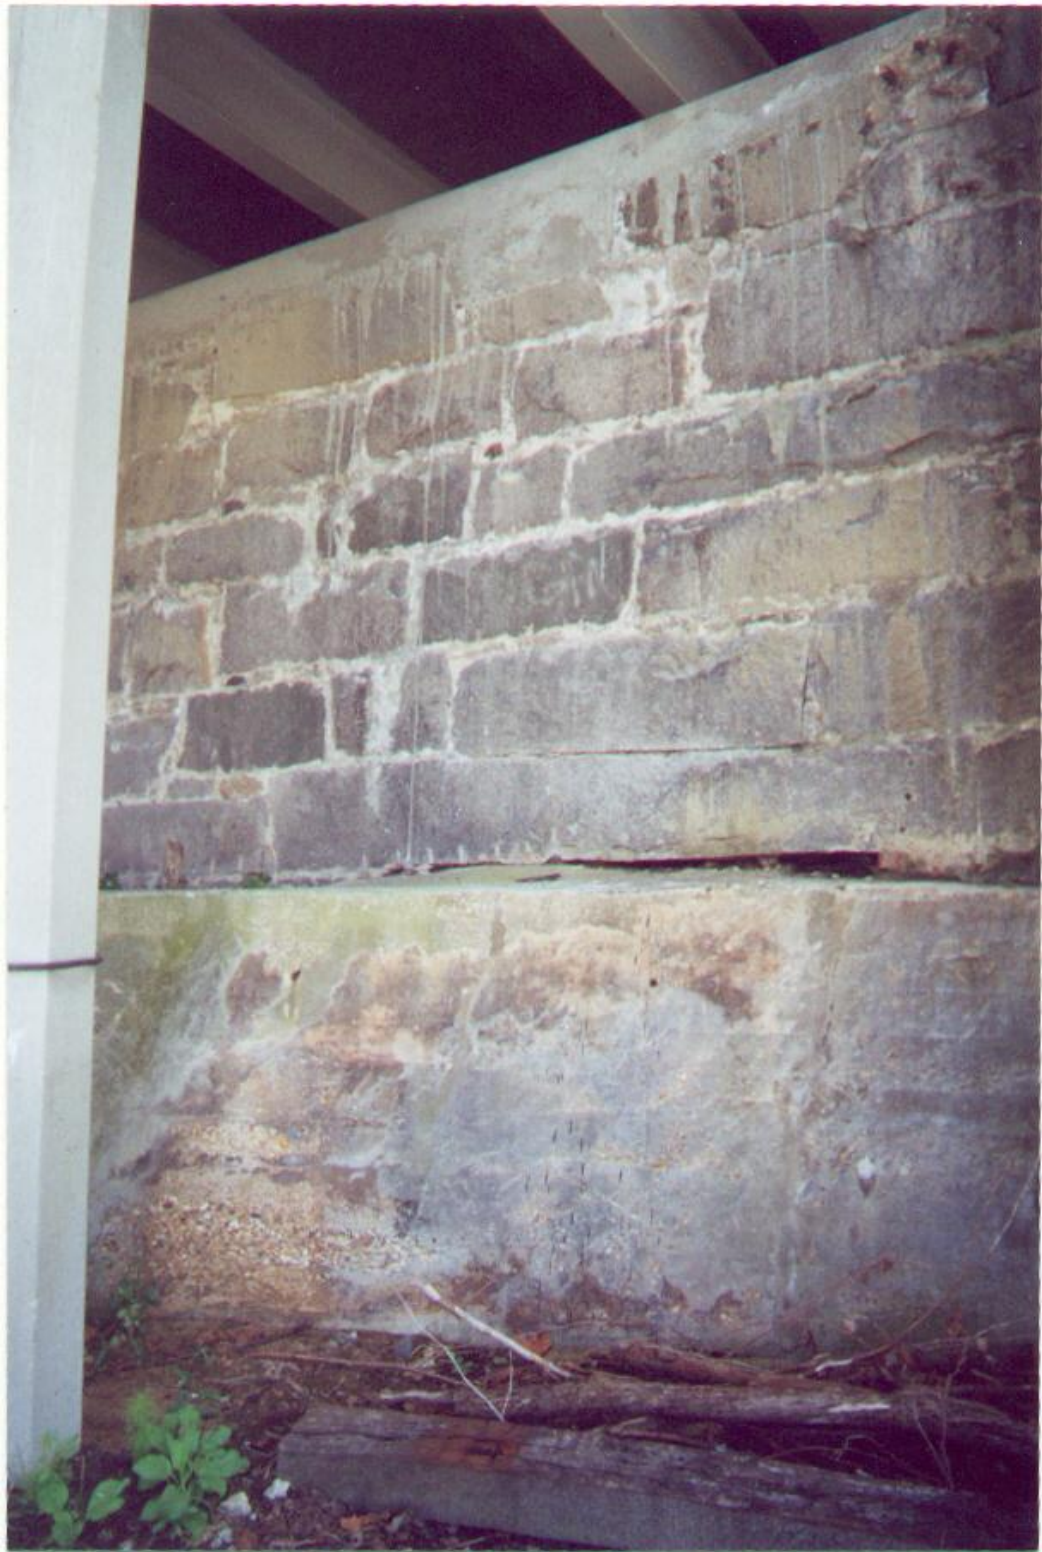
Figure 52

Another view of the same structures as in Figure 51.

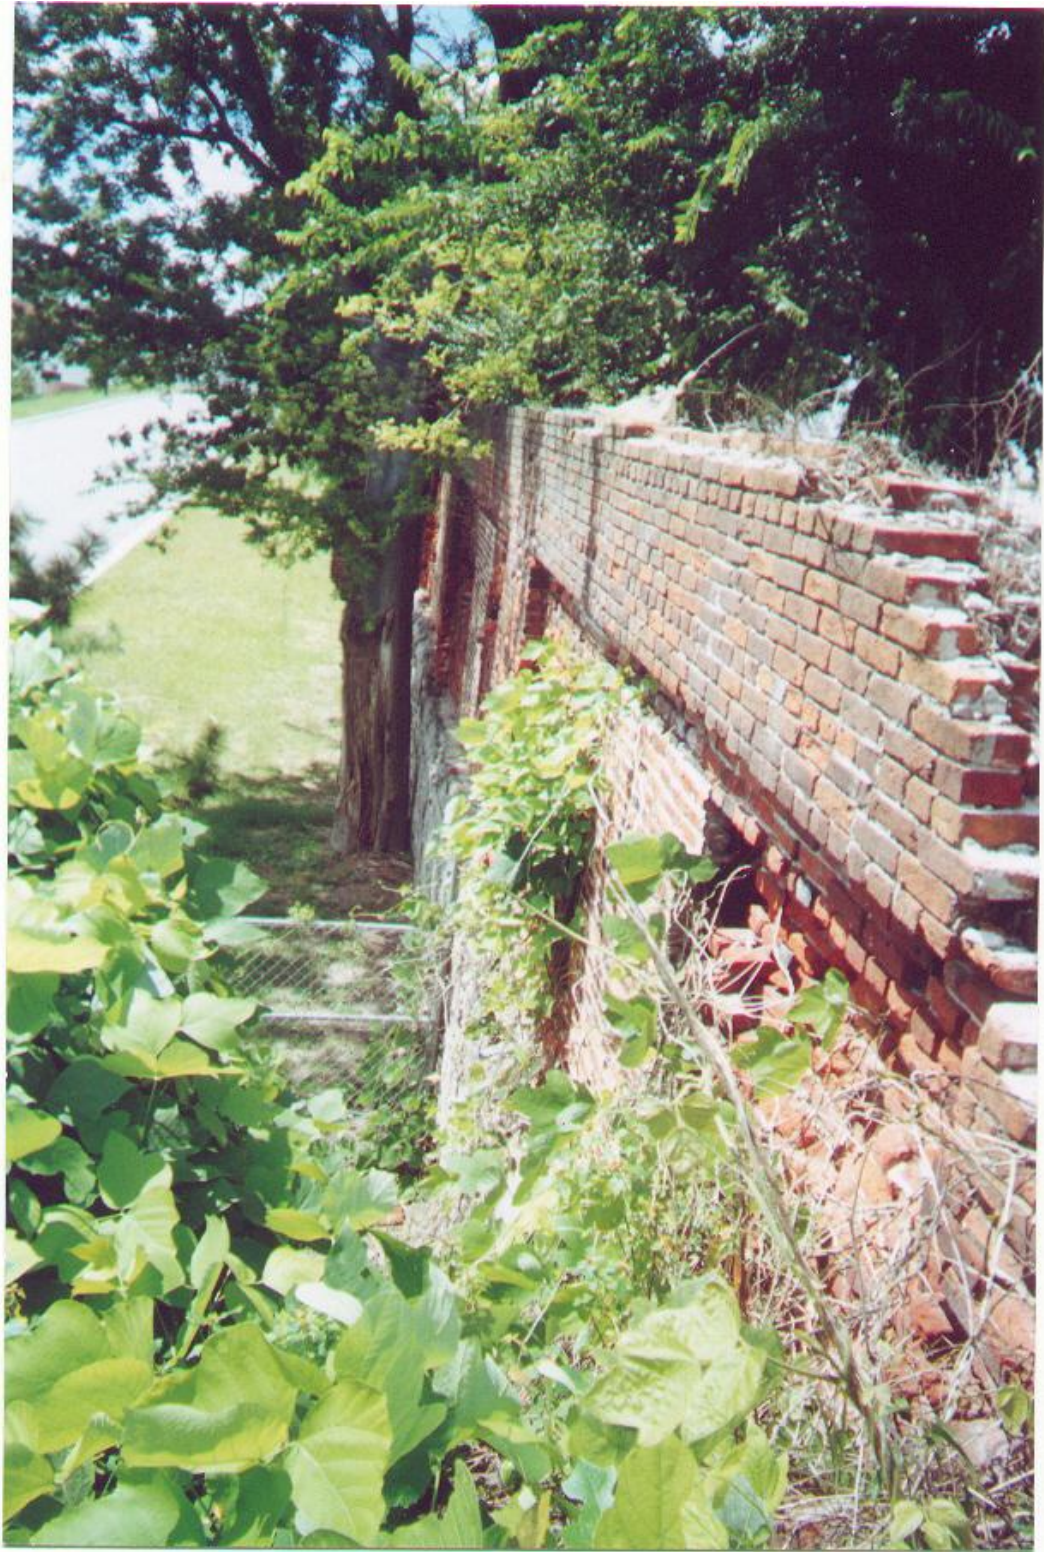
Figure 55

Ruins of rear wall of car shop in northeast corner of Block 247.

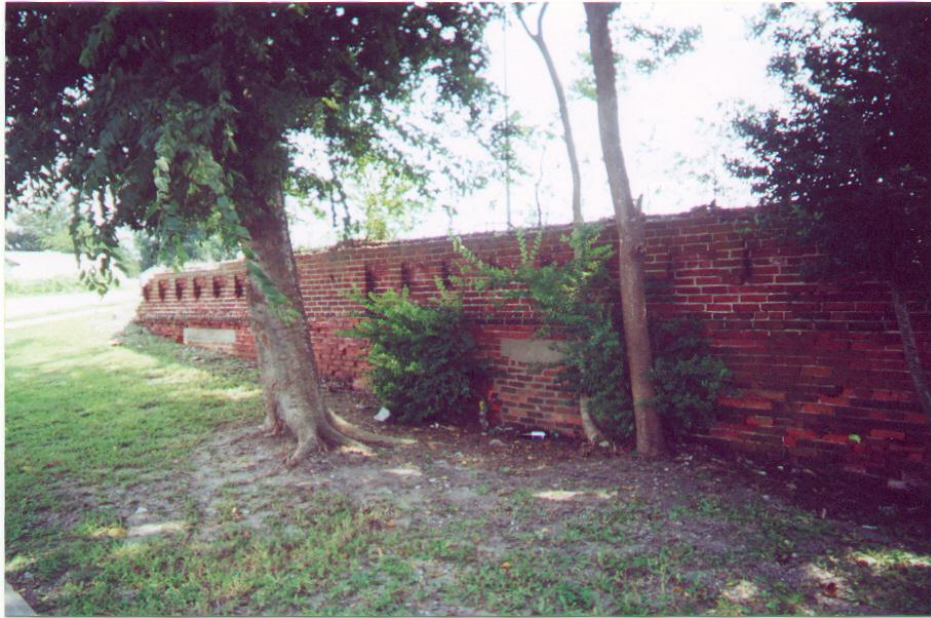
Figure 56

Long shot of the same wall as seen in Figure 55, on Hanover Street side.

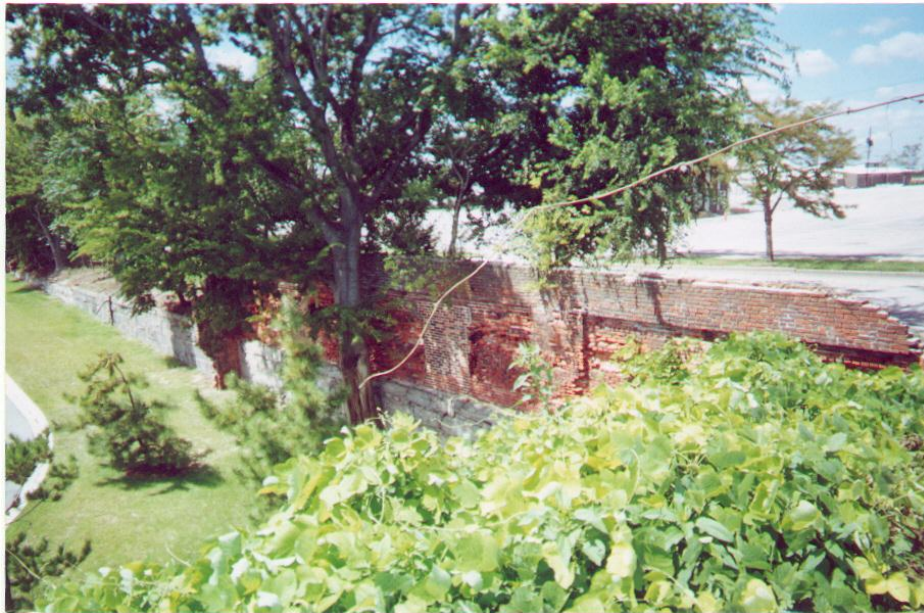
Figure 57

Note granite foundation below old car shop walls.

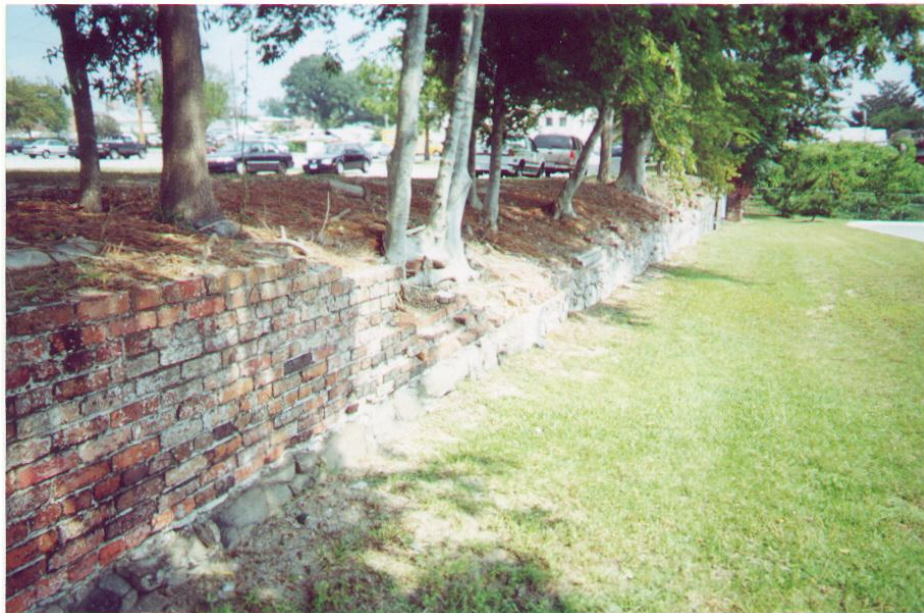
Figure 59

Shot of car shop wall looking in side Block 247 looking east to 3rd Street.

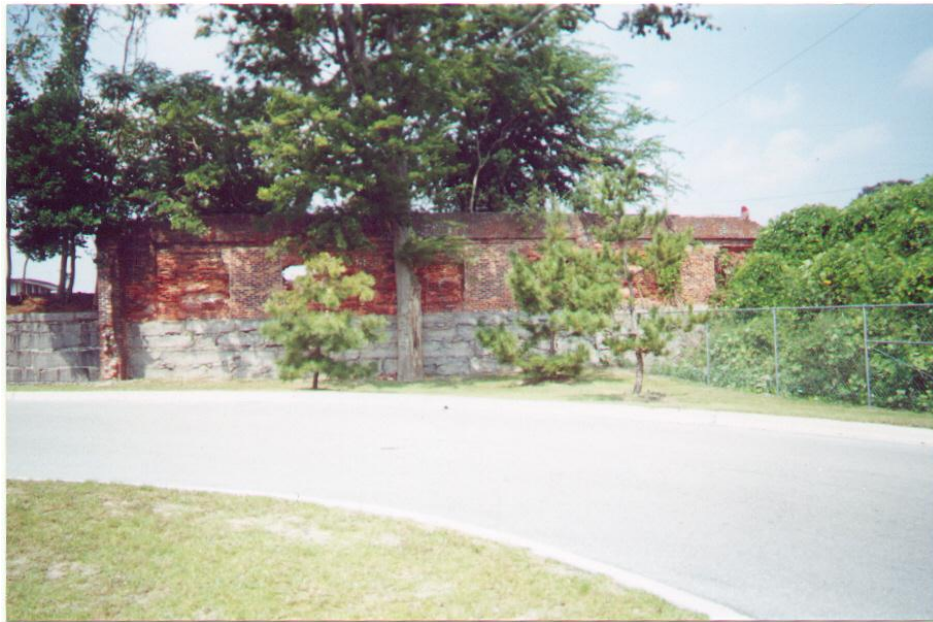
Figure 62

Car shop ruins at far northeast corner of Block 247 near the 3rd Street Bridge.

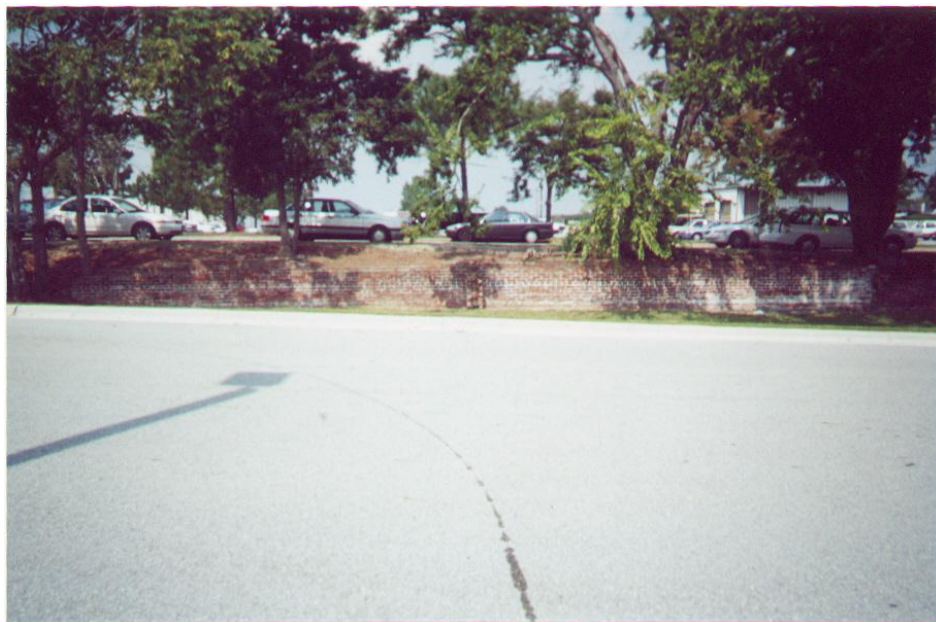
Figure 65

Long shot of car shop walls from inside Block 247.

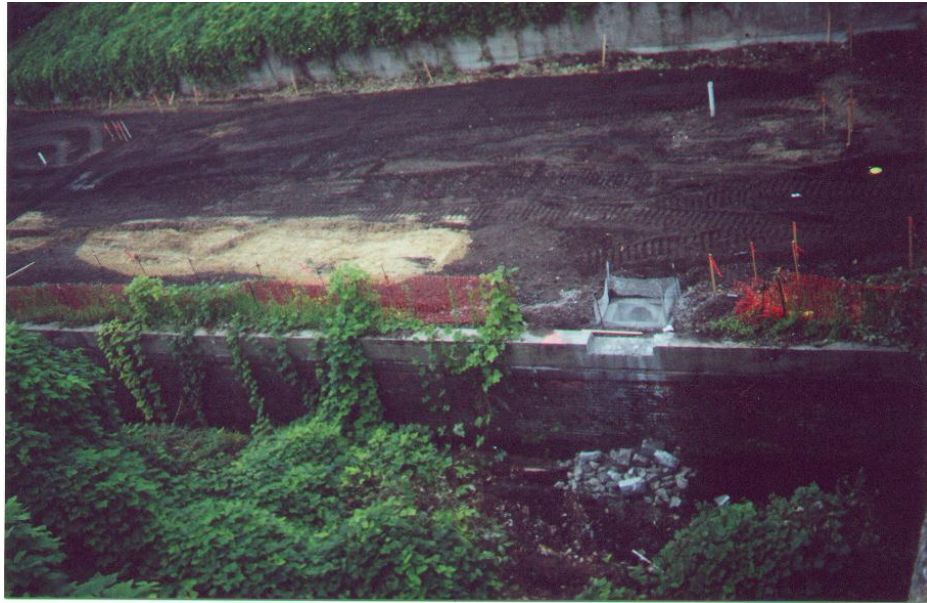
Figure 73

Retaining wall as seen from the south side of the 4th Street Bridge.

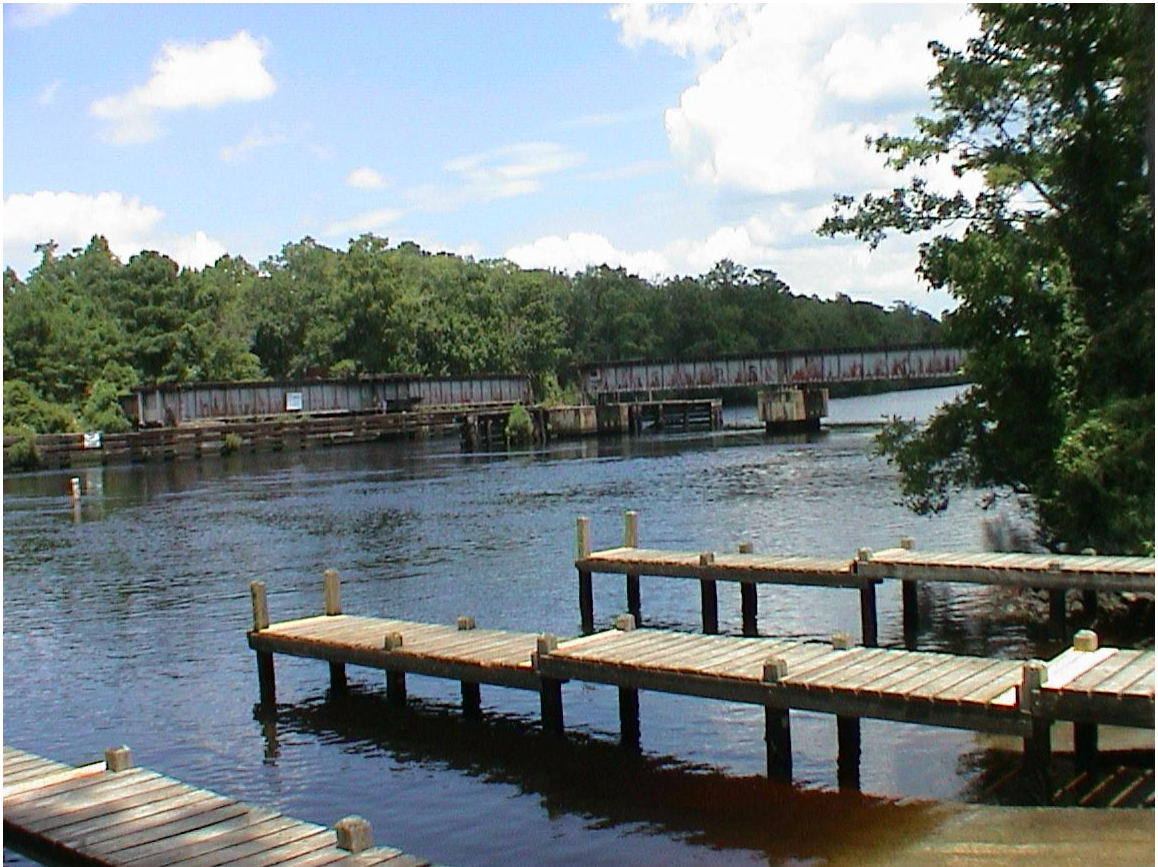
Figure 100

The railroad bridge over the Northeast Cape Fear River is no longer in use.
